# Your Inspection Report

2135 Birchglen Ave.  
Mississauga, ON

**INSPECTION DATE:**  
Saturday, March 20, 2010

RE: Report No. 1035, v.2  
2135 Birchglen Ave.  
Mississauga, ON

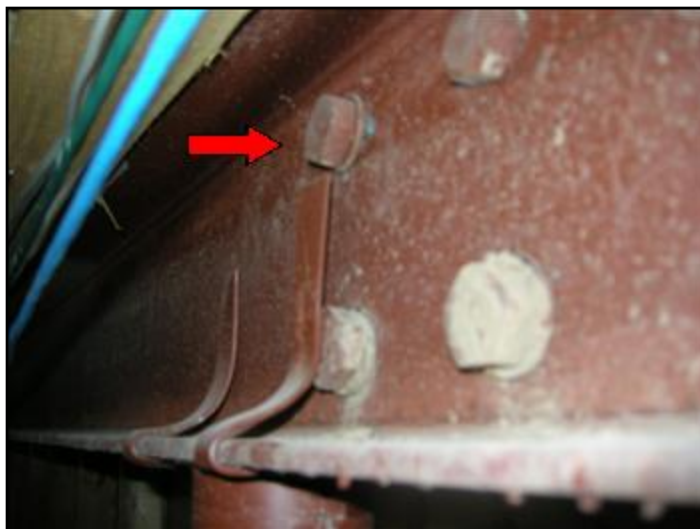
**Condition:** • Beam to beam connection is loose.

**Location:** Center basement (west side)

1. Loose nut/bolt

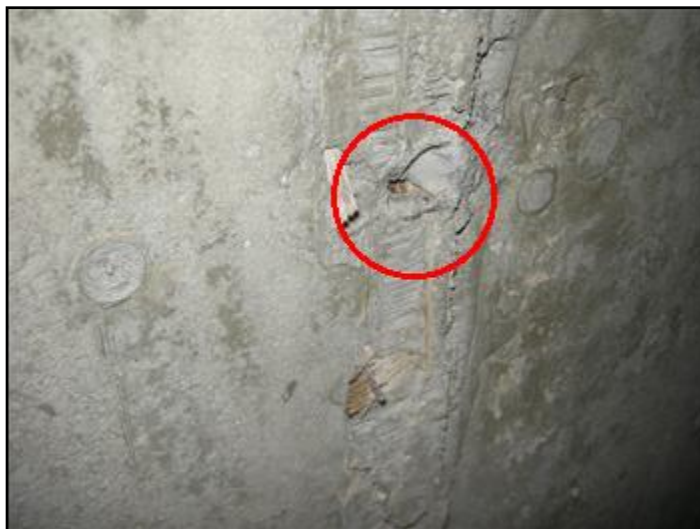
**Condition:** • [Exposed cast-in-place concrete foundation wall has holes in the surface](#)

The tie-rod holes may have been filled in from the outside. This cannot be confirmed during a visual home inspection. Consult with the builder.

2. Tie-rod holes not sealed

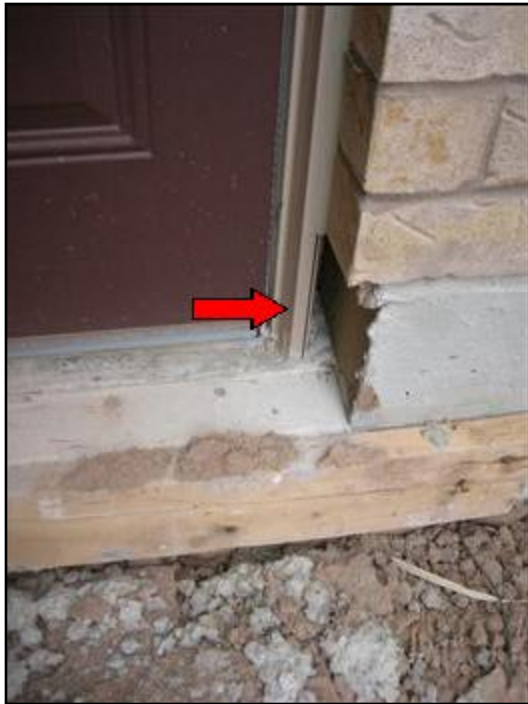
**Condition:** • [Water leakage at doors and windows or at the top of the foundation](#)

**Location:** Rear door from exterior to garage and South vehicle door trim

3. Gap at rear man-door to garage

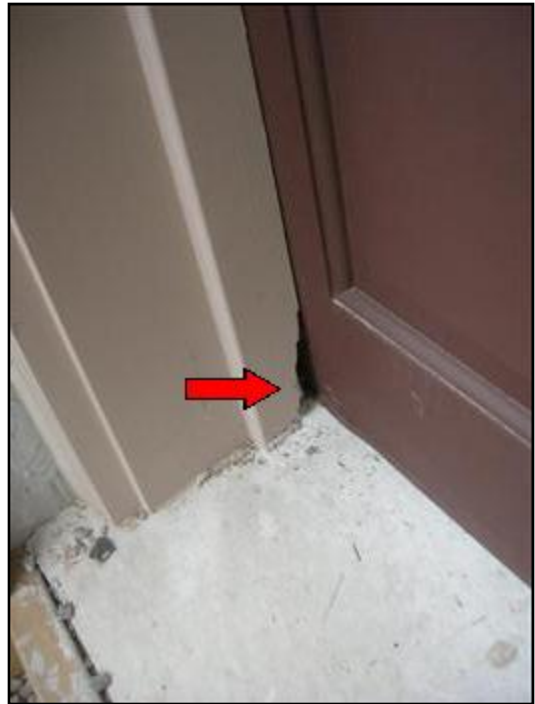
4. South garage vehicle door

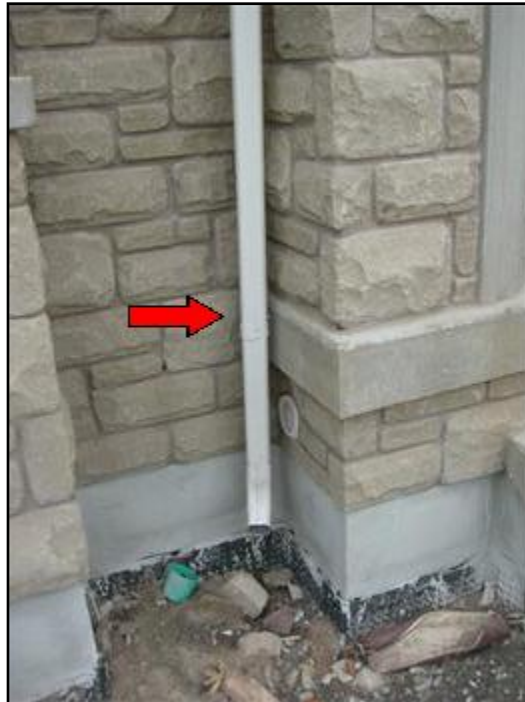
**Condition:** • [Eavestroughs or downspouts not performing properly](#)

Loose downspout at front door noted.

5. Requires support

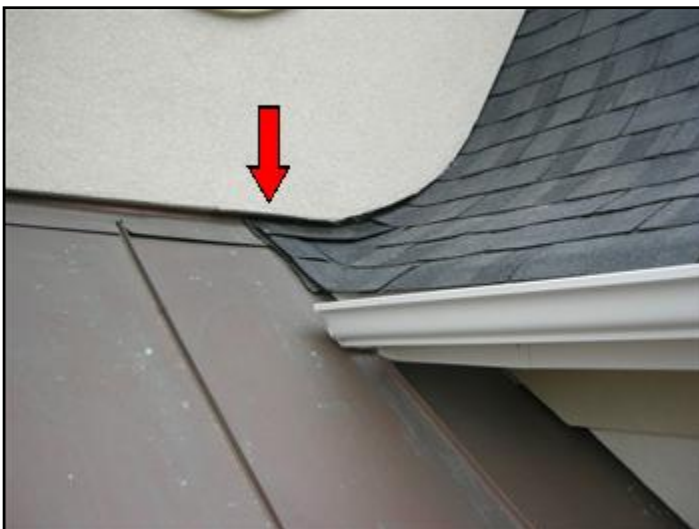
Drywall tape has come loose and dropped at the north garage ceiling. The area directly above this features an unusual transition from asphalt shingles to metal roofing. This is a location of interest and should be considered a vulnerable area. It is entirely possible that the failing tape has nothing to do with the roof and simply fell as a result of not enough mud combined with a cold moist environment.

6. A vulnerable area

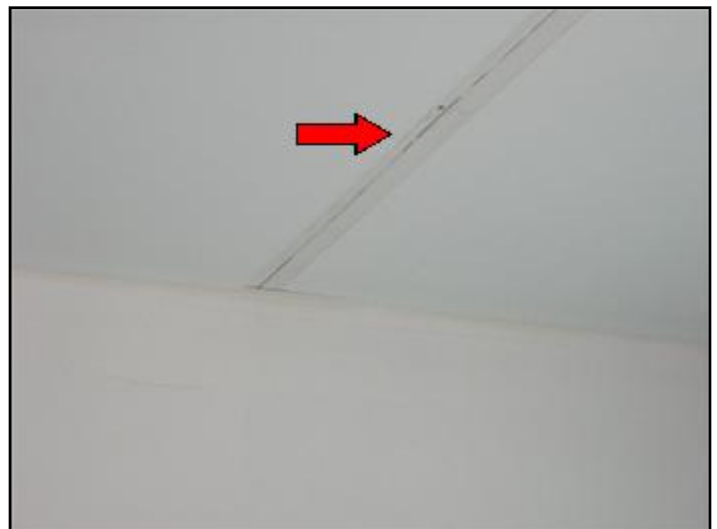
7. Area where drywall tape has fallen

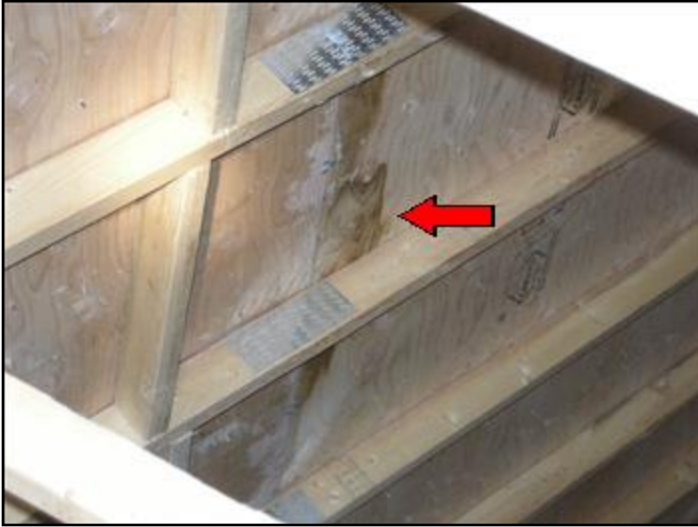
Daylight visible at peak of roof framing (viewed from access hatch) and staining noted at plywood sheathing. Both conditions should be commented on by builder and confirmed to be a water tight system.

8. Staining noted

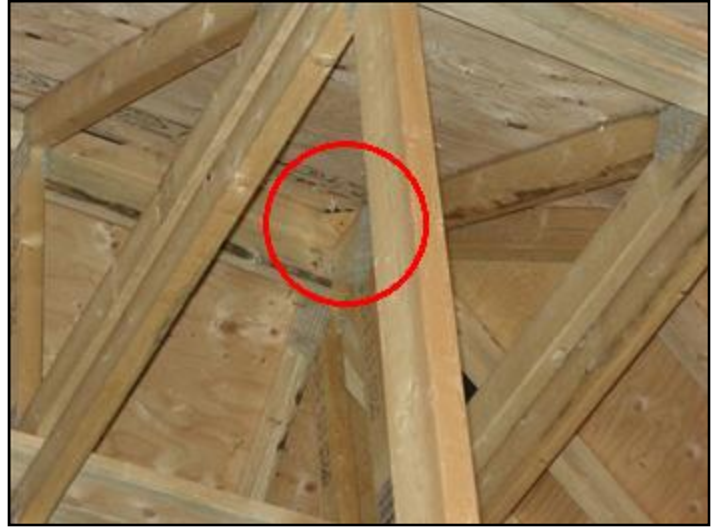
9. Daylight visible

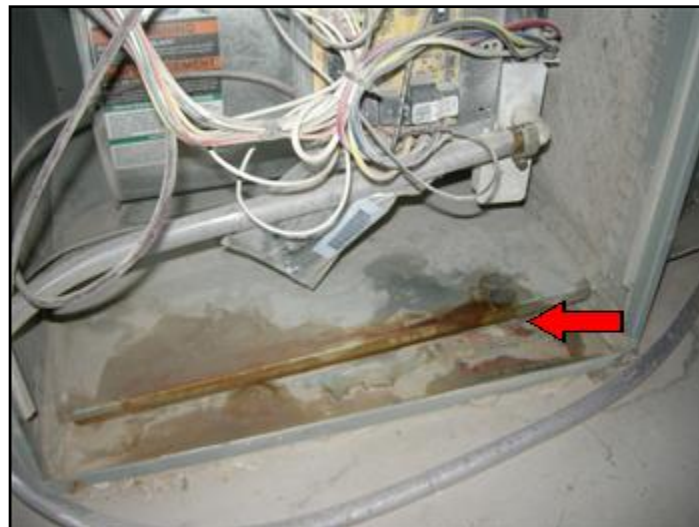
**Condition:** • [Heating, ventilating or air conditioning \(HVAC\) systems not installed properly](#)

**Location:** South Basement

10. Leaky condensate line noted

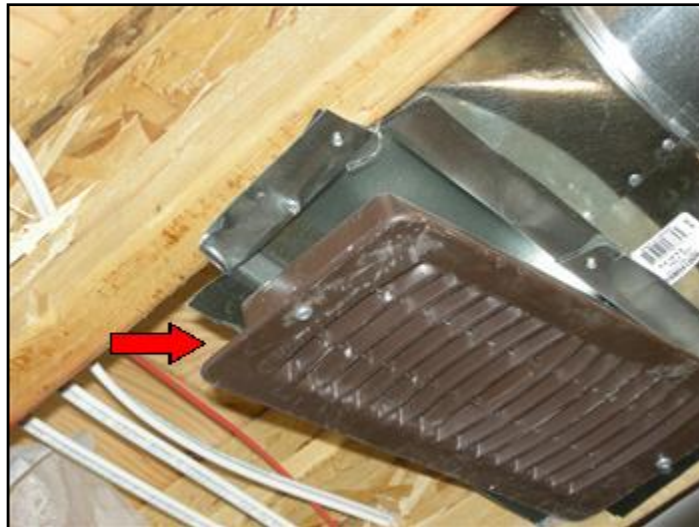
**Condition:** • [There are gaps between heat diffusers, cold air return grilles and ventilation grilles and the adjacent surfaces](#)

**Location:** North Basement

11. Loose grille

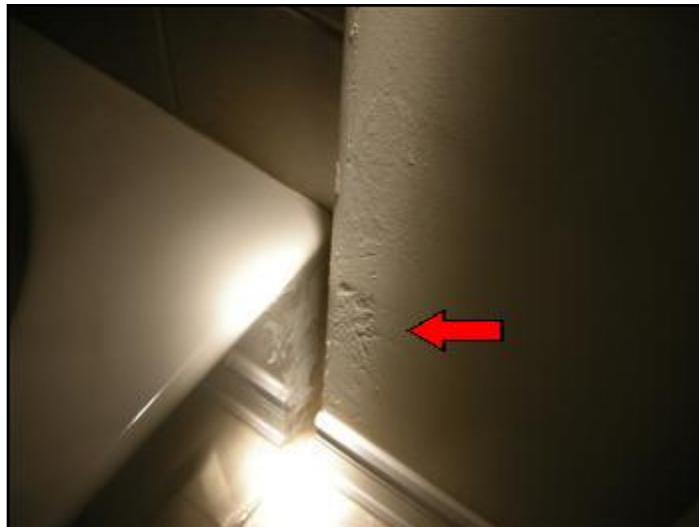
**Condition:** • [Finished surface is rough](#)

**Location:** Northeast Bathroom beside tub at faucet end

12. Rough finish

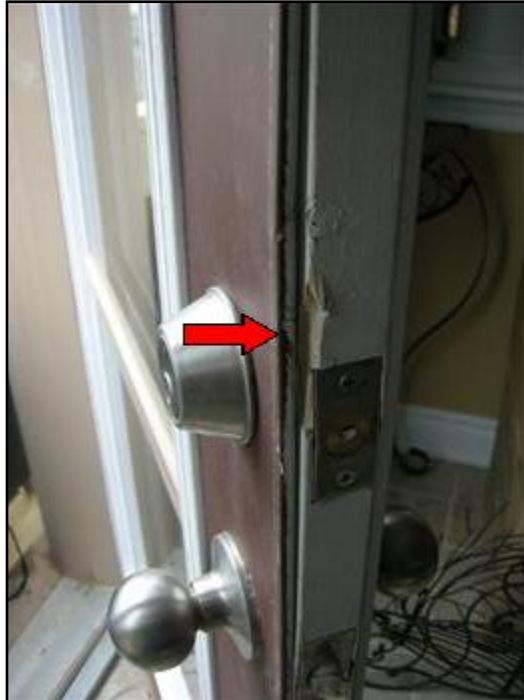
**Condition:** • Door to deck shows damage.

**Location:** Kitchen

13. Damage at door

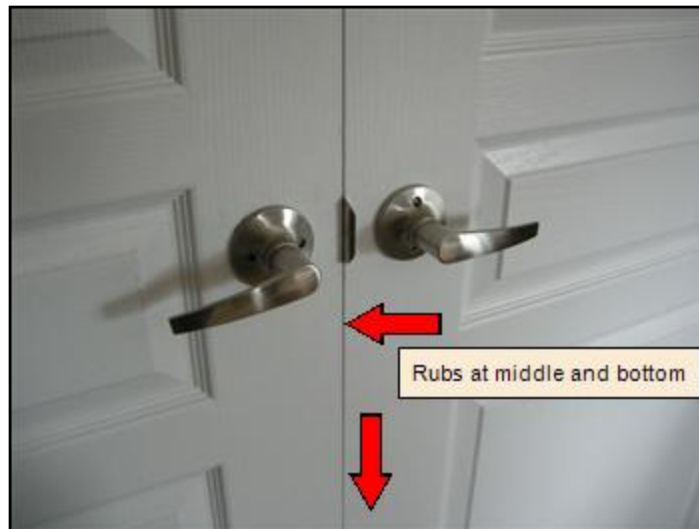
**Condition:** • [Door rubs on the doorjamb or does not latch](#)

**Location:** Master Bedroom Double Door Entrance

14. Master bedroom door

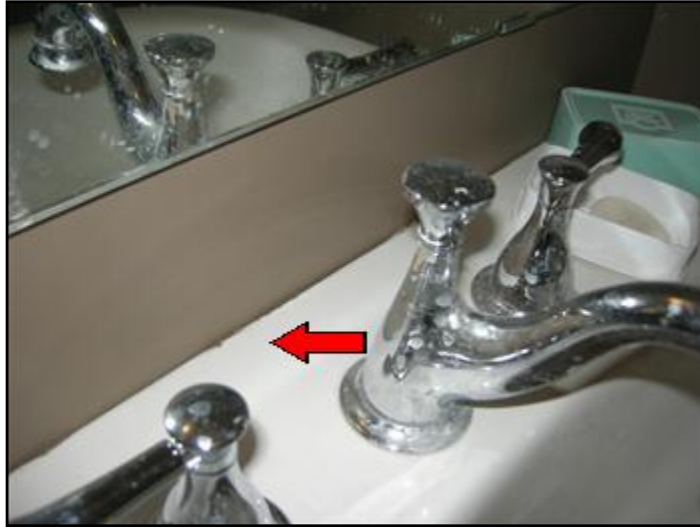
**Condition:** • Sink to wall union should be sealed.

**Location:** First Floor Powder Room

15. *Should be sealed*

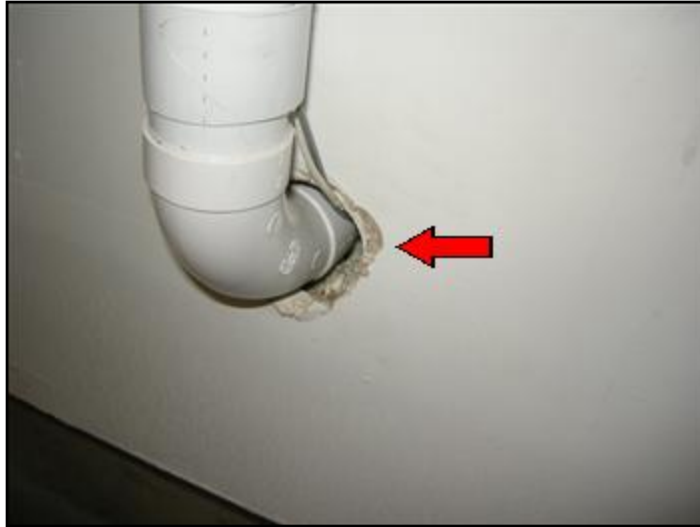
**Condition:** • Gas proofing is required in a garage.

16. *Caulking required*

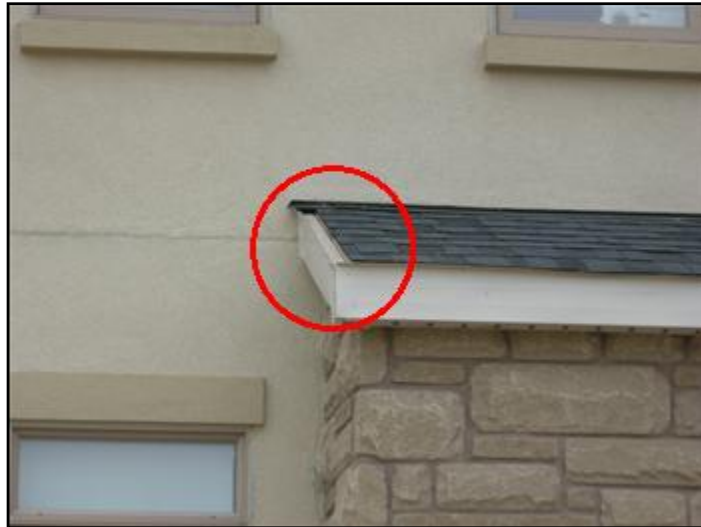
**Condition:** • Roof covering

Incomplete roofing noted at gas fireplace roof.

17. This condition on both sides

**Task:** Repair or replace

**Time:** Immediate

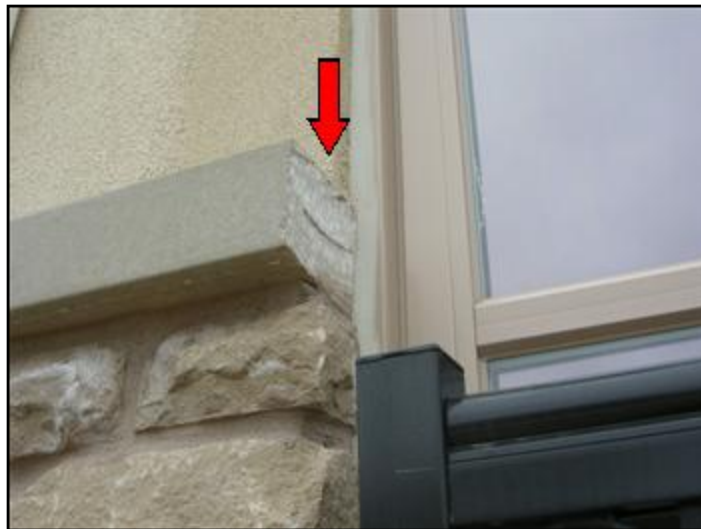
**Condition:** • Site modified coping detail has left an inconsistent finish.

18. Exposed cut end of coping

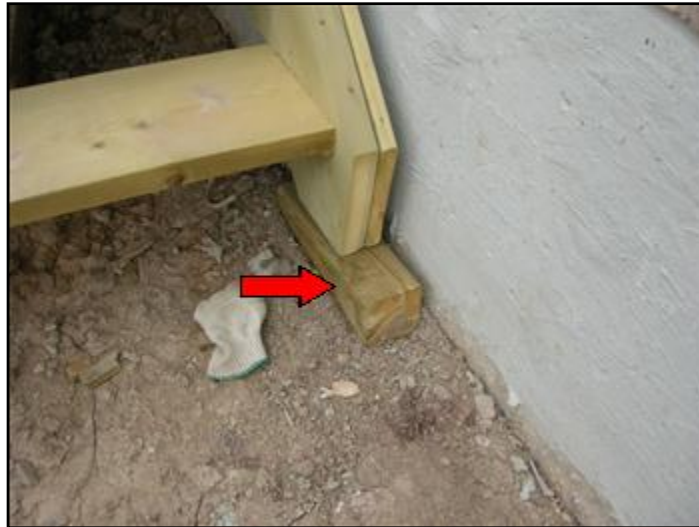
**Condition:** • Stair support off kitchen deck will need proper support.

19. *Temporary support*

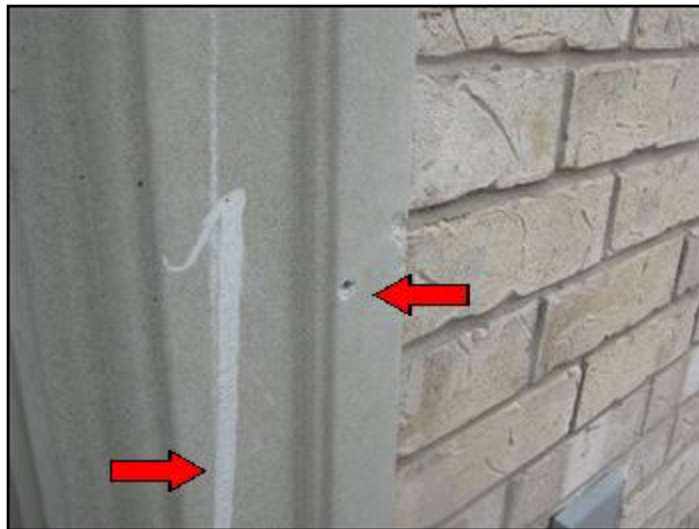
**Condition:** • Damage to exterior finishes noted at kitchen door.

20. *Scratches and holes*

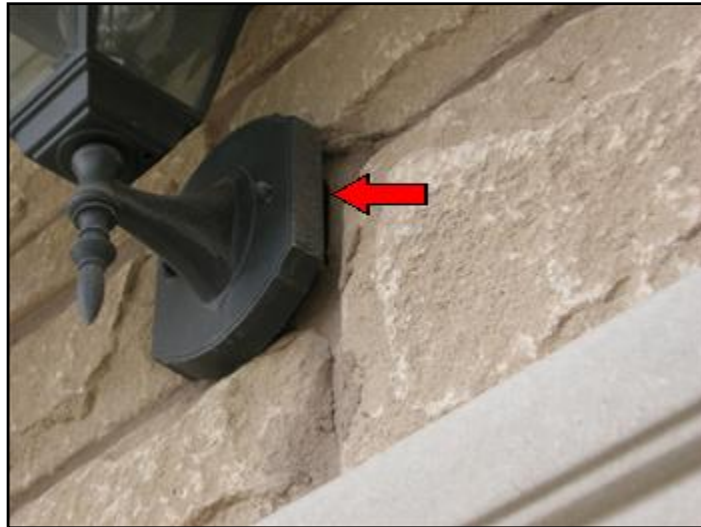
**Condition:** • All the lights at the east side (garage) require sealing to ensure water/insects to not have access.

**21. Gaps behind fixtures**

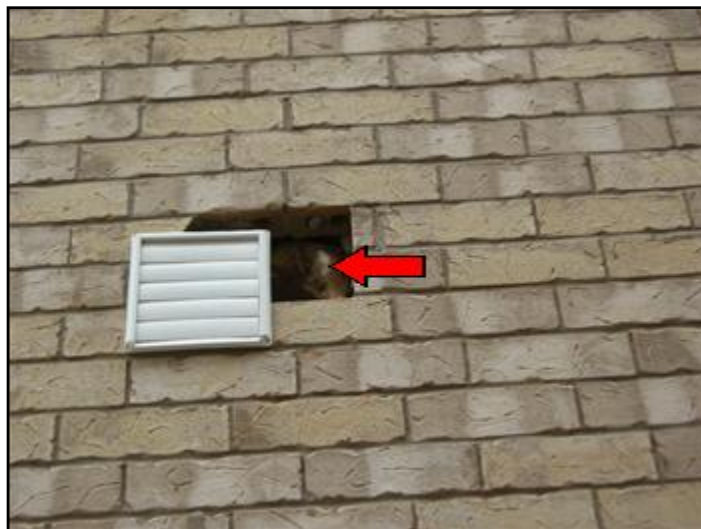
**Condition:** • Unfinished brickwork where kitchen exhaust exits at side yard noted.

**22. Unfinished brickwork**

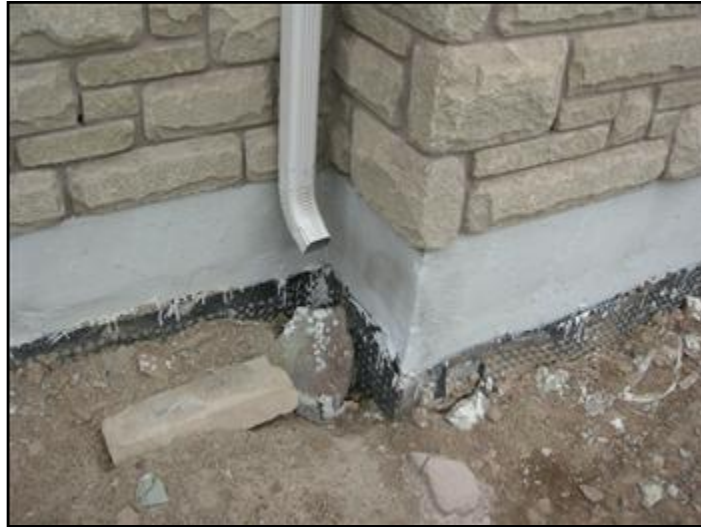
**Condition:** • Missing splashblocks/rainwater leaders

23. Incomplete work noted

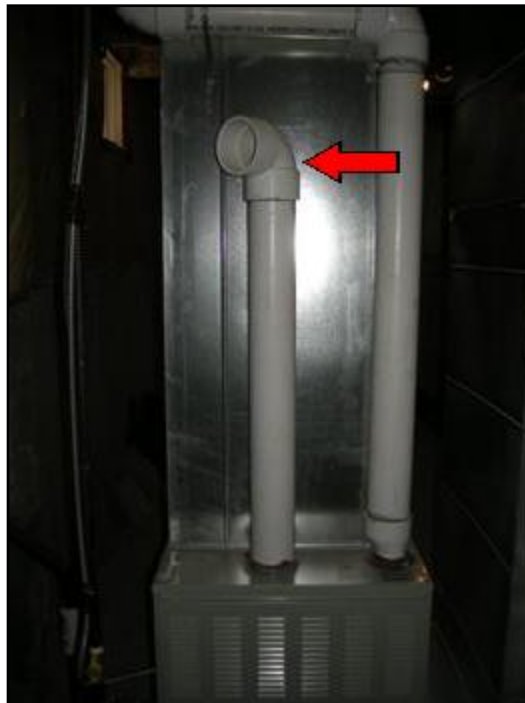
**Condition:** • A better building practice is to extend the combustion air intake to the outside.

24. Extend to the outside

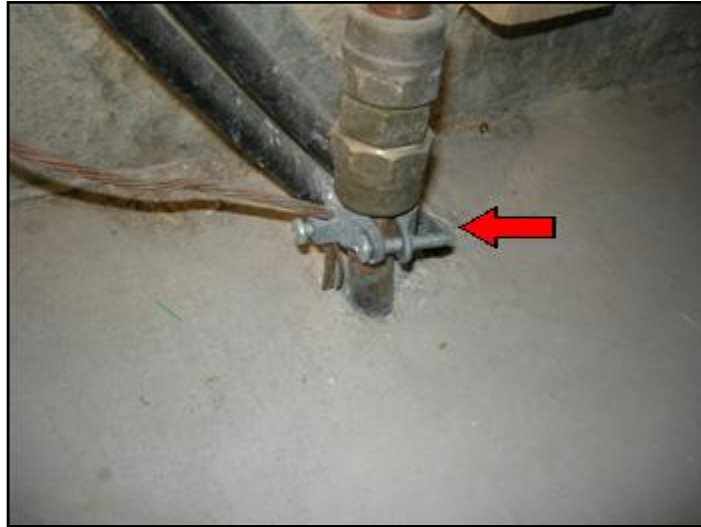
**Condition:** • Loose ground clamp at water meter noted.

25. Loose

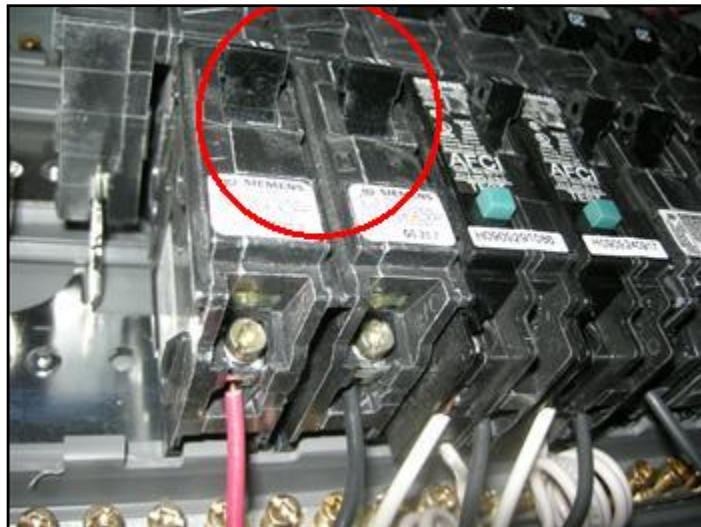
**Condition:** • Missing link at multi wire circuit

26. Should be linked

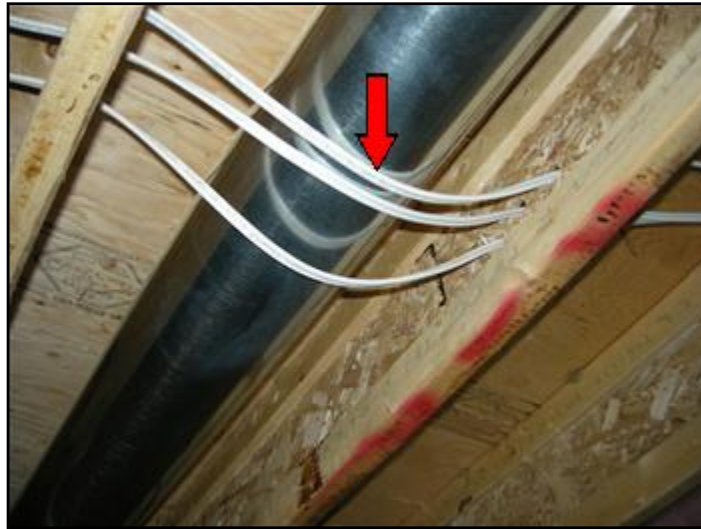
**Condition:** • 1" of clearance required at the ductwork.

27. Too close

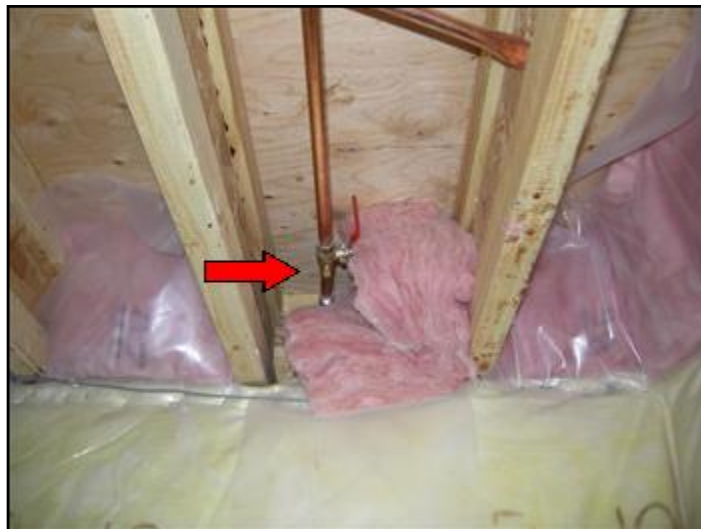
**Condition:** • Incomplete insulation/vapour barrier was noted.

**Location:** Throughout basement header area

28. Example at east basement
